LONG-TERM PERFORMANCE AND RELIABILITY ASSESSMENT OF 8 PV ARRAYS AT SANDIA NATIONAL LABORATORIES

J. E. Granata, W. E. Boyson, J. A. Kratochvil and M. A. Quintana

Sandia National Laboratories, Albuquerque, NM

Photovoltaic Systems Evaluation Laboratory

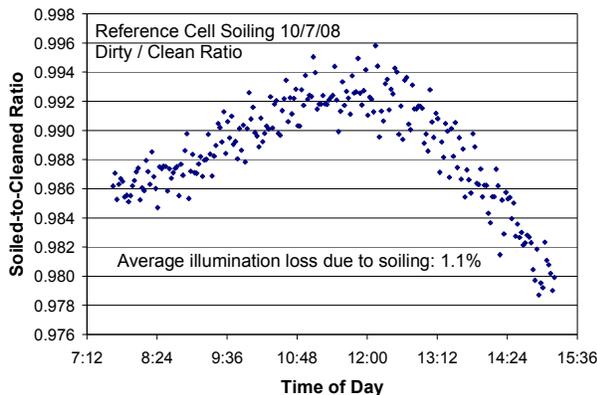
Figure 2 Effect of soiling on arrays

The shape of the curve demonstrates the increased loss at high air mass values early in the day and late in the day

for the soiled reference cell due to increased scattering. The average illumination loss due to soiling is 1.1%.

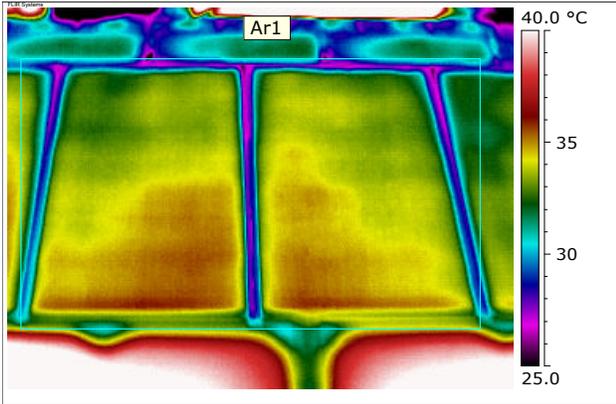
Figure 4 Sample IR images in the field for System #3

A portable infrared camera is a valuable tool when diagnosing module losses. Infrared (IR) images were taken of the modules in pairs. Figure 4 is an example of the IR images from well-behaved modules in the center of the array. Using the scale from the IR images, the modules across this system were operating at a temperature of 32°C on average.

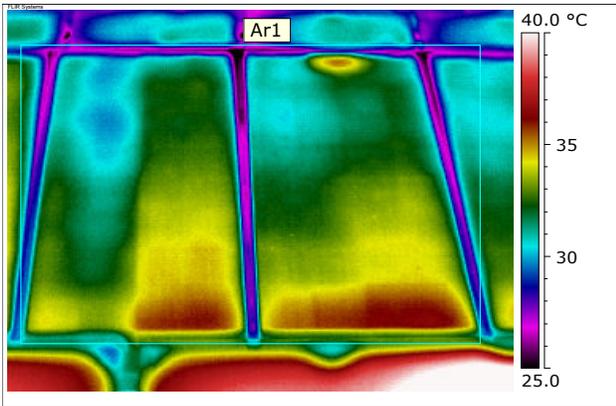
IR images can also demonstrate hot spots, open circuits in a string within a module, hot junction boxes, or non-uniformities across a module. Figure 5 demonstrates two of these issues: a hot junction box on the top right and possible mismatch of two strings on the left module, observed as running cool.

Figure 5 Sample IR images in the field for System #3 with issues observed; module on the left demonstrated intermittent response in IV check

Following the IR images, the Voc was measured for each module. All the modules were disconnected from one another and individually tested with a handheld meter to check Voc. When no obvious issues were found in Voc, the Daystar was used to scan curve traces on each module. During this process, module number 51 of 88 was found to be intermittent. The curve traces on the 87 other modules were as expected. Module 51, shown in

Figure 5 on the left, was removed from the string and replaced with a module of similar vintage from storage. The system was then retested with the Daystar; the performance parameters were within measurement error of the original performance measurement.

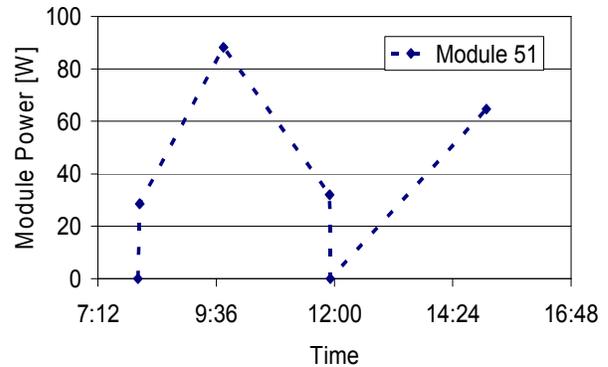
The next step in the troubleshooting process is to understand what went wrong with this module. Figure 6 shows select power measurements as a function of time during a day-long performance test on Sandia’s two-axis tracker. A companion module from the same array was measured for comparison. The power drop-outs occurred throughout the day, and did not correlate with insolation level or module temperature. When the module was responding, the performance was similar to the companion module (not shown).

Figure 6 Power versus time for the intermittent module during day-long test on tracker

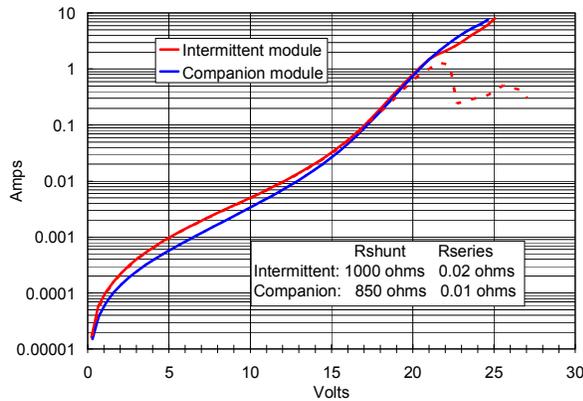
Dark IV curves were also measured on the intermittent module and analyzed [7]. A companion module from the same array was measured for comparison. See Figure 7. Module 51 demonstrated intermittency during dark IV measurements as well as during outdoor performance measurements, as observed in the dashed curve in Figure 7. However, the calculated module resistance values are similar between the modules, suggesting the problem is not in the solar cell material. It was possible to induce the intermittency by manipulating the pigtailed, suggesting the failure mechanism is in the attachment of the pigtail to the circuit.

Figure 7 Dark IV and diode parameters for modules from System #3

The remaining steps to prove this hypothesis include using non-destructive imaging techniques of the module to look for damage, and then finally to take the junction box apart. This process is currently underway.
